A summary of a NIOSH fire fighter fatality investigation

June 25, 2012

A Career Captain Dies and 9 Fire Fighters injured in a Multistory Medical Building Fire—North Carolina

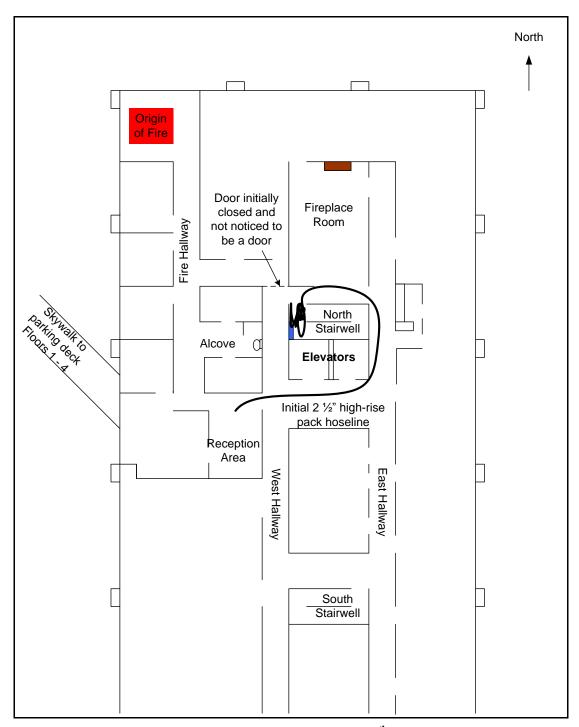
Diagram 2. Placement of initial hoseline at 5th floor standpipe. Hoseline on landing had numerous kinks in it.

Several crews using the stairwell had dropped additional high-rise packs in the stairwell. The hoseline was inadvertently charged, causing multiple kinks on the 5th floor between the standpipe connection and the 5th floor doorway. The E2 crew, stretching the hoseline, noticed it was charged and flowed water for a few seconds to cool down the area. At 1251 hours, the E2 crew's SCBA low-air alarm began going off so they used the elevators to return to the ground floor to change SCBA cylinders. Approximately one minute later, the R3 crew on the 5th floor grabbed the hoseline, could not get water to flow, and reported it to Command. The E1 engineer proceeded to connect to the FDC for the parking deck standpipe system in case they had been mislabeled.

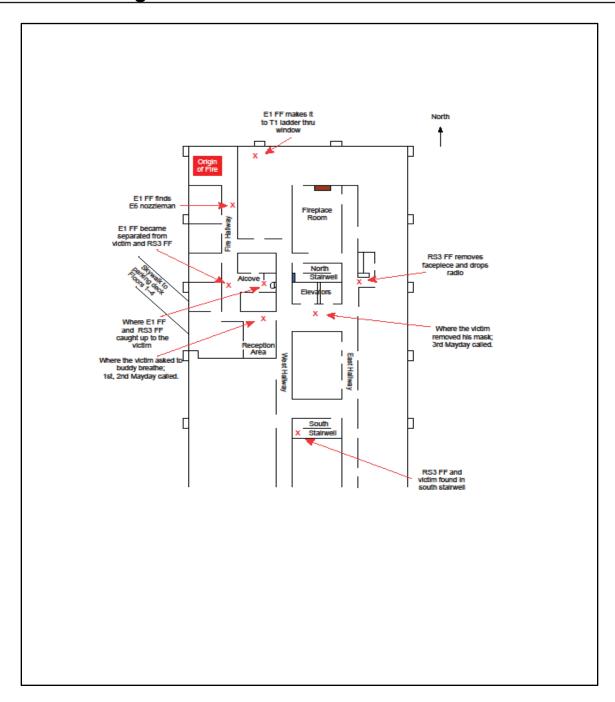
Diagram 3. Critical movement of the E1 fire fighter, RS3 fire fighter, and the victim.

At 1311 hours, E6 got water on the fire for the first time. R3 was back on E2's original hoseline but reported to Command that there was no water and the IC ordered them out. E6 requested air bottles be brought to fire floor. At 1316 hours, E8 was on the fire floor, reported heavy smoke and heat and requested that the north stairwell be ventilated. Flames began venting out the side A windows that were broken. BC1 requested a ladder truck be positioned on side A for possible use in getting water on the fire venting from the windows. E6 requested additional hoseline to reach the fire venting on side A. The R3 crew, at the 5th floor north stairwell door, noticed the E8 captain and another fire fighter were untangling high-rise hoseline in the stairwell. One of the fire fighters from R3 was extremely low on air and the victim (R3 Captain) told the R3 engineer to take him down the stairs. The victim proceeded down the hallway instead of exiting down the stairwell. Another R3 fire fighter (with only a few years' experience) and an E1 fire fighter noticed the victim headed down the hallway so they followed after the victim. The victim and two fire fighters ended up in a small alcove with a bathroom at the end of it off the hallway to the fire room. All 3 fire fighters' SCBA low air alarms were going off. The two fire fighters grabbed the victim and headed back into the Side A hallway. The victim was following the R3 fire fighter but the E1 fire fighter got separated from them in the hallway due to the heavy smoke. The E1 fire fighter realized he was extremely low on air and thought about calling a Mayday. He took about ten steps and ran into the E6 fire fighter on the hoseline from T1. Shortly after, the E1 fire fighter followed the E6 hoseline to the window and got on the ladder just as he ran out of air (see Photo 3).

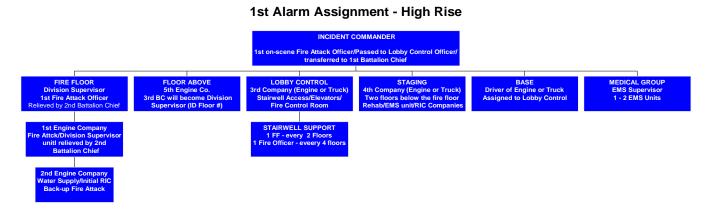
Below is an example model of a first-alarm response to a reported high-rise fire. The resources deployed are four engine companies, two truck companies, one heavy-rescue company, and one battalion chief. Every fire department having high-rise buildings in their response area should develop a deployment model for a high-rise response. The model can be modified to meet a department's deployment strategy for a high-rise response.
